OEM Crash Test vs Aftermarket

• 2018

Honda OEM Vehicle Versus Repaired Honda Using OEM Parts

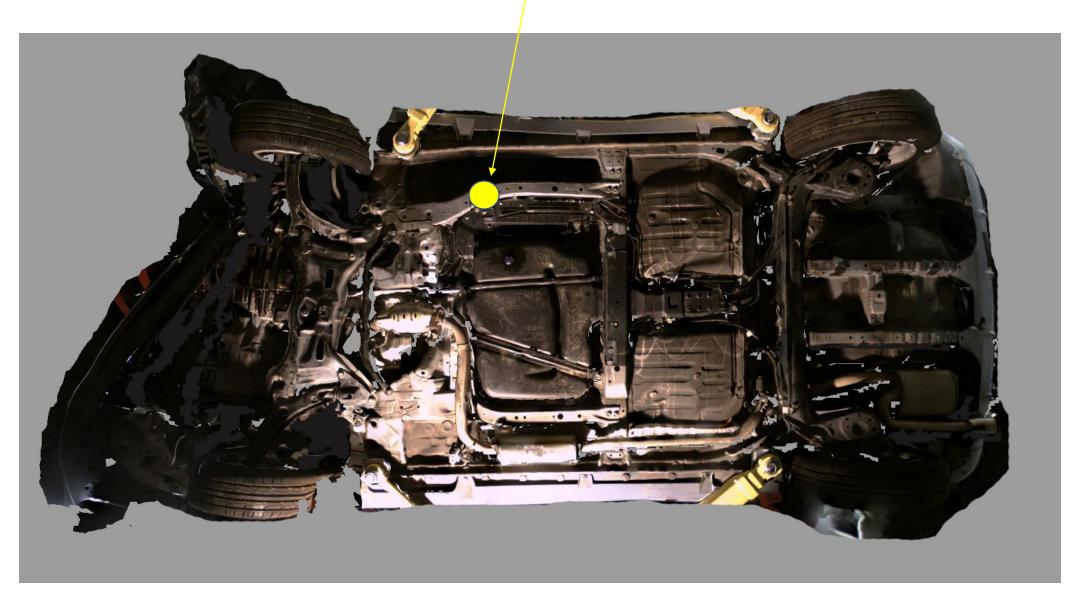
Bottom Frame Rail Sensor Location

Structural collapse underneath the occupants caused injurious vertical loads

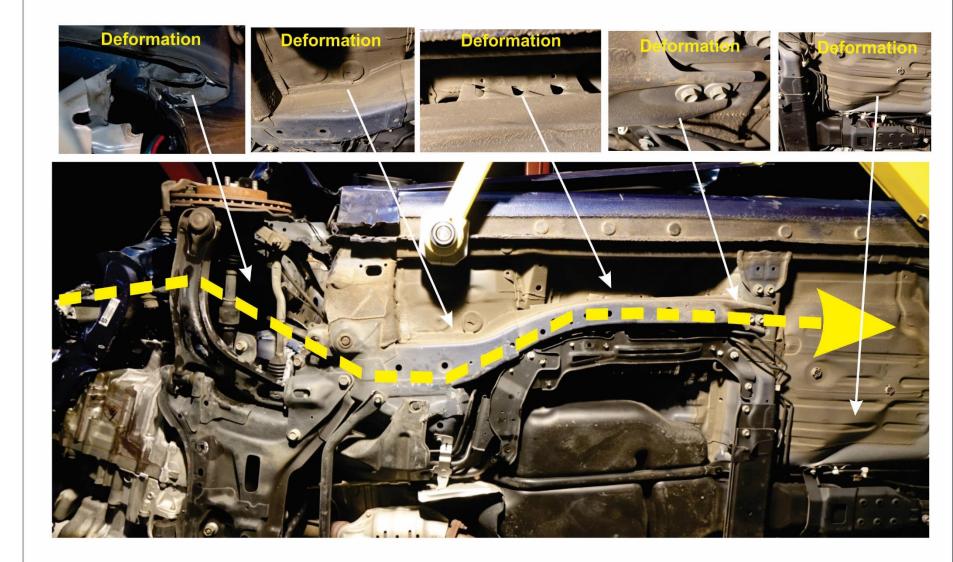
Aftermarket Parts

Virtually Identical Frame Component Damage on Honda OEM Parts Repair

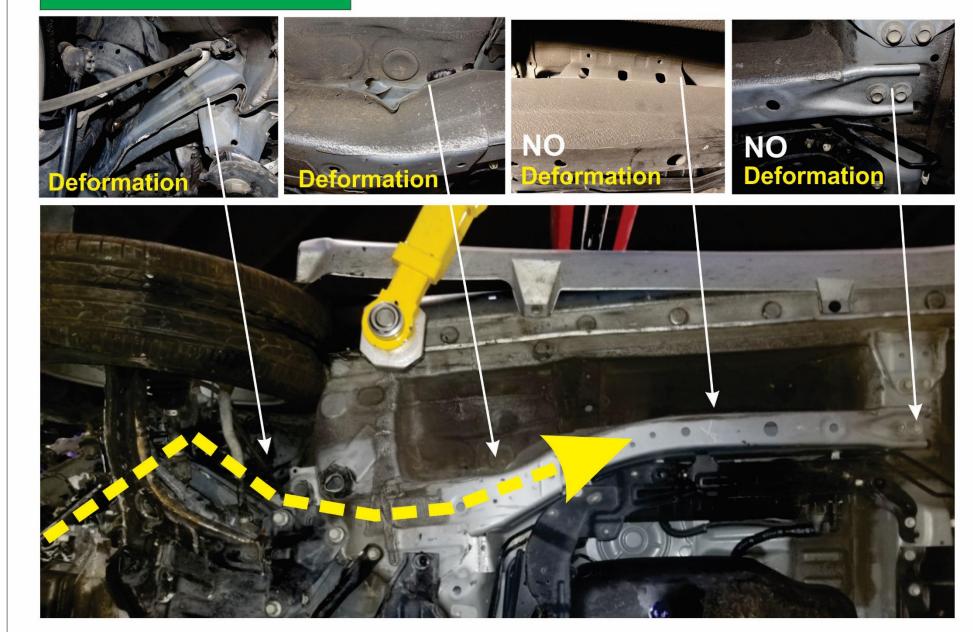
Honda OEM Parts

Substantially Increased Damage Underneath the Occupant Compartment Using Aftermarket Parts

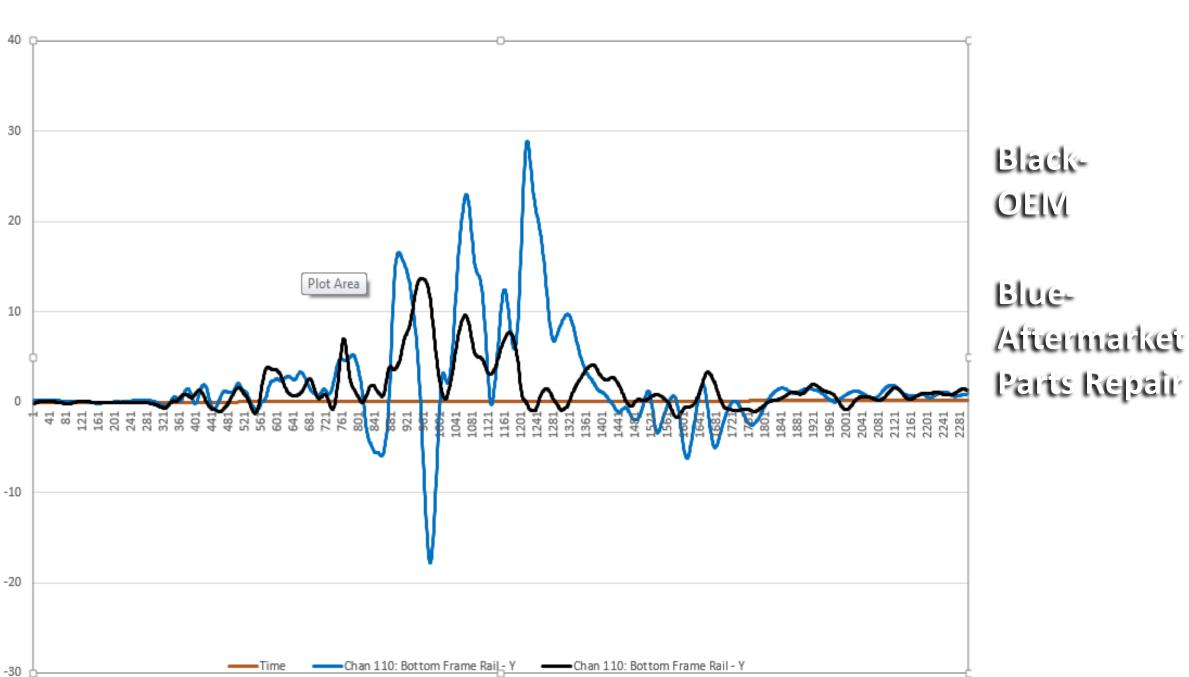
Bottom Frame Rail Sensor - Y

13 Inches of Load Limiter Payout vs. 8 Inches OEW Parts

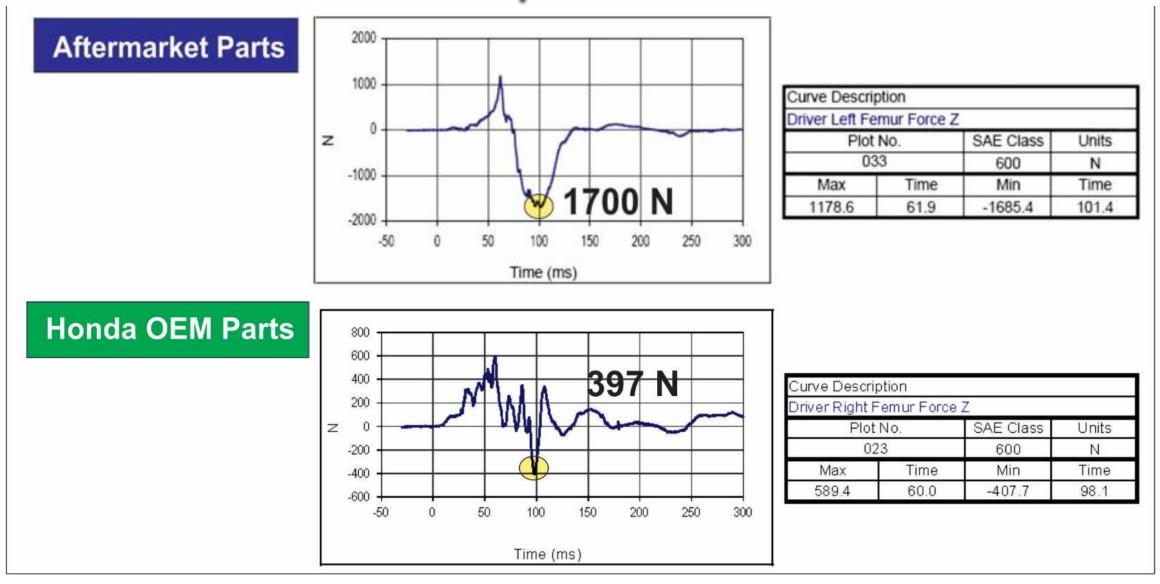
Again, The OEM Parts Repaired Vehicle Performs Much Closer to the OEM, than Aftermarket Part Repair

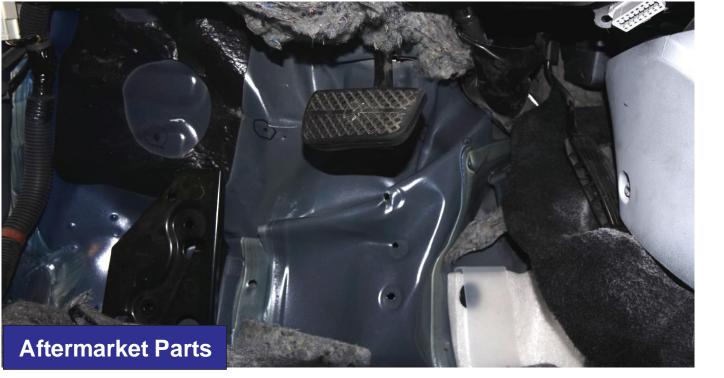
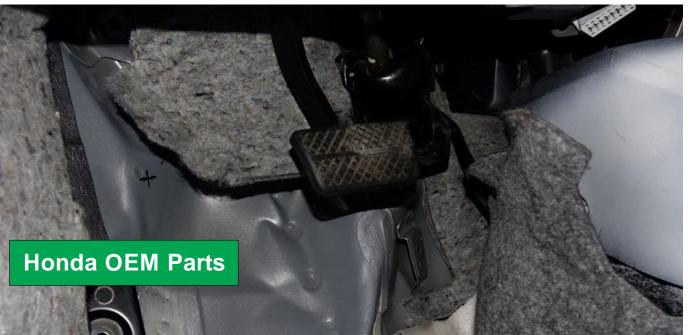
Brake Pedal Displacement Differences Demonstrate Major Floor Pan Intrusion in the Aftermarket Part Vehicle
